Update “With-Site-Visit” Reserve Study

Pinehurst at Waldenwood HOA

Everett, WA

Report #: 18664-1
For Period Beginning: January 1, 2014
Expires: December 31, 2014

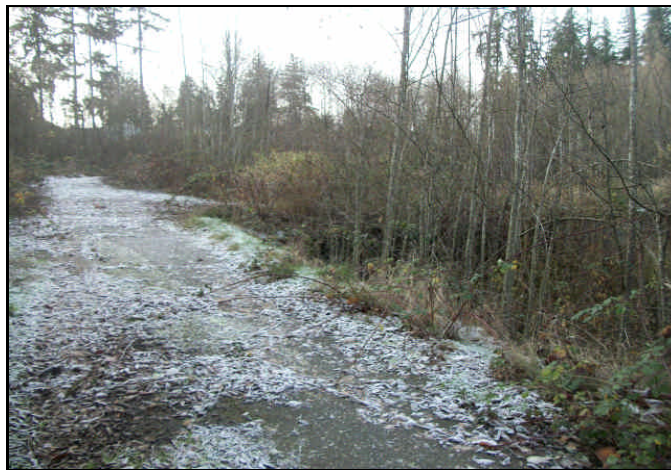
Evaluation: We had limited visibility of this asphalt as the gate for the retention pond area was locked. From our very restricted viewpoint, we noted stable condition with no major damage, upheaval or significant raveling (loss of binder).

Even with ordinary care and maintenance, plan for eventual large scale resurface (overlay) at roughly the time frame below. As timing draws nearer, consult with asphalt vendor/consultant for recommendations and complete scope.

As routine maintenance, keep roadway clean, free of debris and well drained; fill/seal cracks (hot rubberized crack fill) to prevent water from penetrating into the sub-base and accelerating damage. While sealcoat can be applied, most likely cost/benefit ratio of this type of road with low use, adjacent to stormwater ponds, etc. most likely not cost effective. Sealcoat is most beneficial on heavily traveled surfaces with low speed and limited drainage. Also, restrictions could apply to this area located adjacent to stormwater ponds.

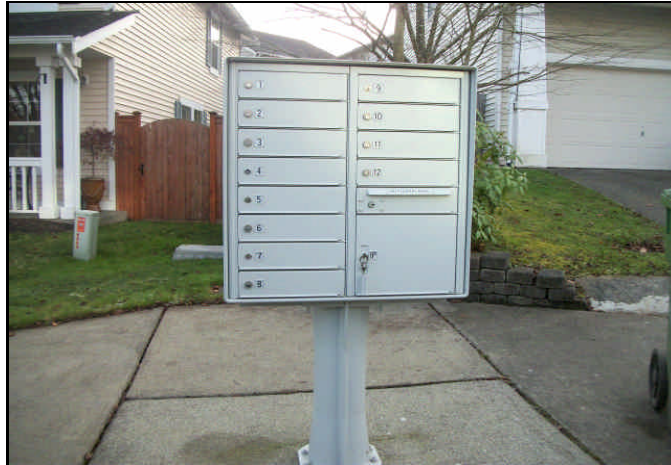
Comp #: 403 Mailboxes - Replace/Repair

Evaluation: No problems observed of metal cluster box stands throughout community. These units were recently (2013) cleaned and painted.

Best to plan for total replacement at roughly the time frame below due to constant exposure, usage and wear over time. Note: USPS has a limited budget for replacement and should not be relied upon for purposes of long term planning.

Inspect regularly, clean by wiping down for appearance, change lock cylinders, lubricate hinges and repair as needed from operating budget.

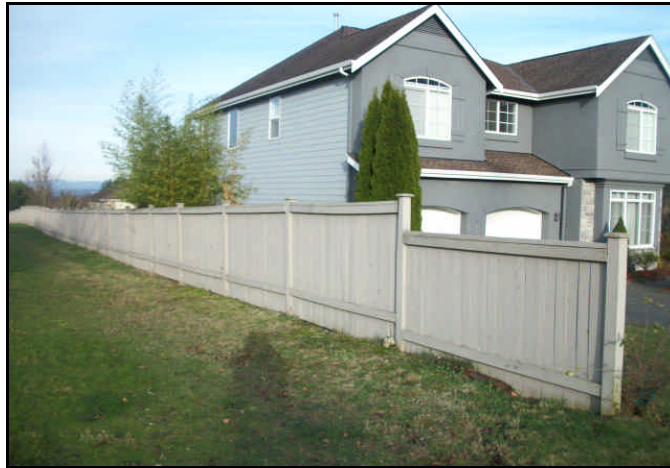
Comp #: 505 Wood Fence - Repair/Replace

Evaluation: We noted the majority of fencing to be in stable condition with no major damage/deterioration observed. Some local repairs, replacements and touch-up as needed were performed in 2013 prior to our site visit.

Best to plan to replace at roughly the time frame below with funding included here for similar style fence. At next replacement, association might want to consider replacing with lower maintenance products like composite, vinyl, etc; typical costs at installation about ~40 to 50% higher, but requires less maintenance and has significantly longer life.

As routine maintenance, inspect regularly for any damage, repair as needed and avoid contact with ground and surrounding vegetation. Regular cycles of uniform, professional sealing/painting will help to maintain appearance and maximize life (component #506).

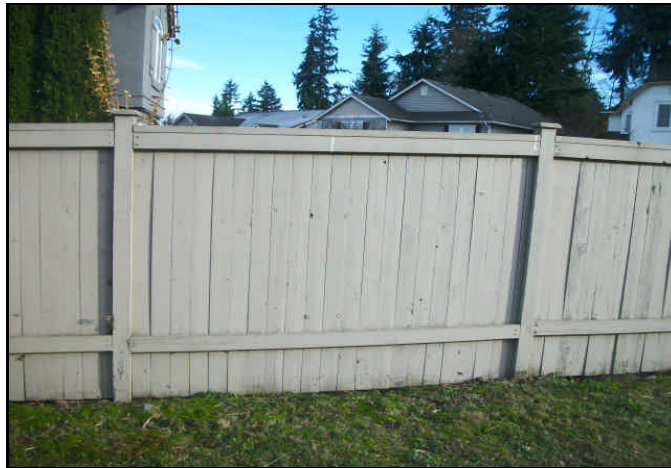
Comp #: 506 Wood Fence - Clean/Stain (Paint)

Evaluation: Surface appearance appears fair with no major fading/deterioration observed. Some spot work in 2013 including touch-up of surfaces.

We recommend planning for routine clean/stain (paint) applications as shown here. Regular uniform, professional sealer applications are recommended for appearance, protection of wood and maximum design life. Remove any contact with ground and surrounding landscape; repair as needed and clean prior to sealer application. Pay particular attention to end grains of fence to help prevent water from wicking into wood; solid, full bodied product provides best protection.

Routine repairs/touch-up should be factored within the operating budget.

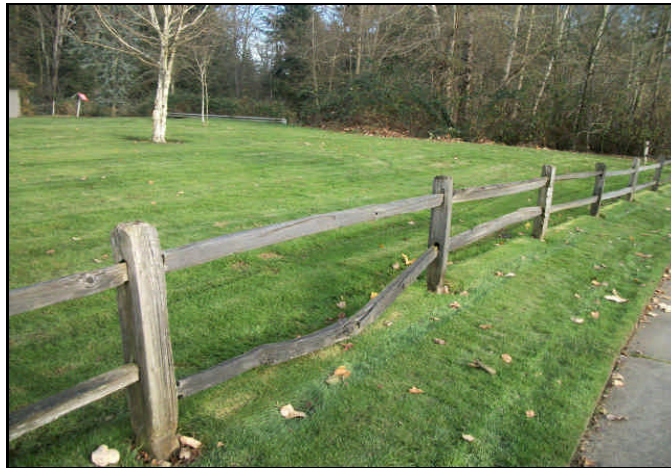
Comp #: 510 Split Rail Fence - Replace

Evaluation: This fencing is weathered and grayed as not being stained which is typical for this style of fencing. We noted one area where the horizontal piece has fallen to the ground and needs repaired.

Best to plan to replace at roughly the time frame below with funding included here for similar style fence. At next replacement, association might want to consider replacing with lower maintenance products like composite, vinyl, etc; typical costs at installation about ~40 to 50% higher, but requires less maintenance and has significantly longer life.

As routine maintenance, inspect regularly for any damage, repair as needed and avoid contact with ground and surrounding vegetation.

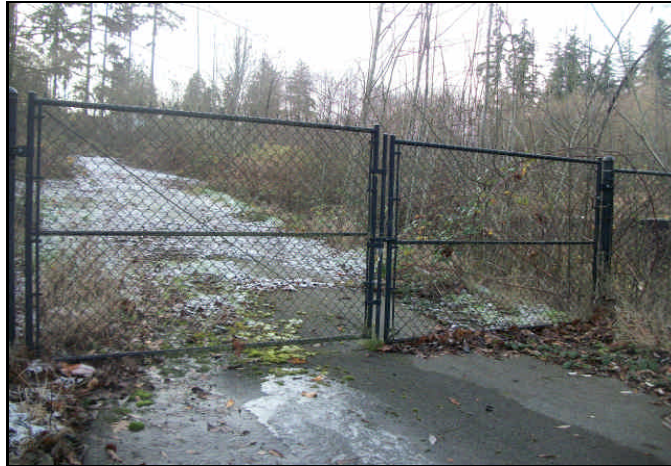
Comp #: 1175 Chain Link Fence - Replace

Evaluation: We had limited visibility of this fencing as majority was not accessible during our site visit as detention pond access gate was locked. No problems observed from our viewpoint.

Even with ordinary care and maintenance, plan to replace this fence as shown below due to deterioration that will result from constant exposure. If vegetation is not kept trimmed back, life could be reduced.

Inspect regularly; clean and repair, stretch locally as needed as part of general maintenance, operating funding.

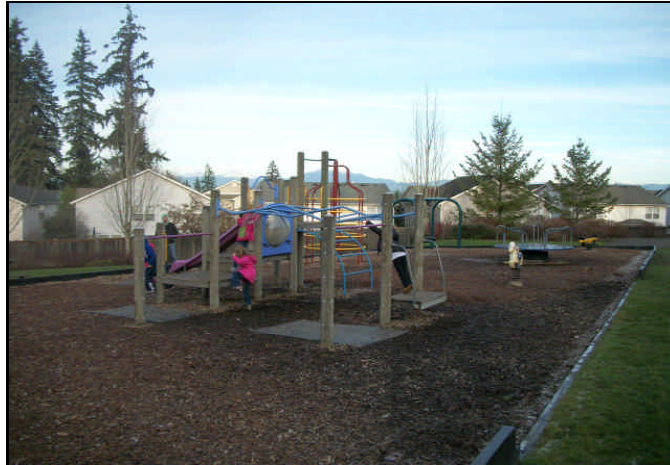
Comp #: 1400 **Play Equipment - Replace**

Evaluation: Equipment includes some timber pieces and metal structures. We noted some wear of the wood, however no major damage/deterioration observed at this time.

Replacement cycles vary depending on the amount of use/abuse, however expect extensive park area renovation at roughly the time frame listed below. This can include work at the borders and fill area replenishment.

Inspect for stability, damage and excessive wear and utilize maintenance funds for any repairs needed between replacement cycles.

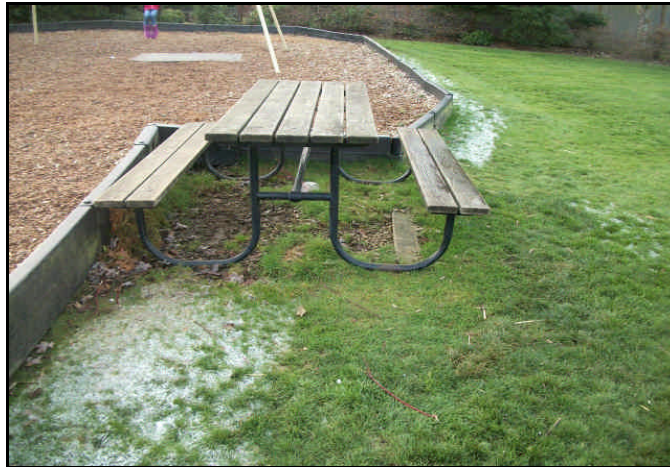
Comp #: 1401 Benches/Picnic Sets - Repair/Replc

Evaluation: We noted wear of the wood seats/tables, however steel structures appear to be stable.

Best to plan for regular intervals of complete replacement at the time frame indicated below, to maintain functionality and a quality appearance. Consider composite, coated metal, concrete or similar as lowest maintenance, typically least annualized cost over time. Possibility exists to replace wood pieces only, however costs shown here are for entire components.

Inspect regularly, clean for appearance and repair as needed from general operating funds.

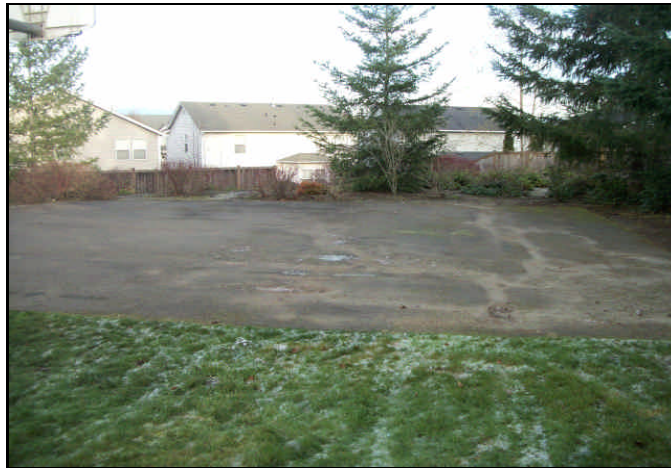
Evaluation: We note some raveling (loss of binder) at surfaces and some dirt stains which could be a sign of adjacent drainage issues. Surface is not lined or coated at this time.

Even with ordinary care and maintenance, plan for eventual large scale resurface (overlay) at roughly the time frame below. As timing draws nearer, consult with asphalt vendor/consultant for recommendations and complete scope.

As routine maintenance, keep clean, free of debris and well drained; fill/seal cracks (hot rubberized crack fill) to prevent water from penetrating into the sub-base and accelerating damage. A coating can provide additional protection.

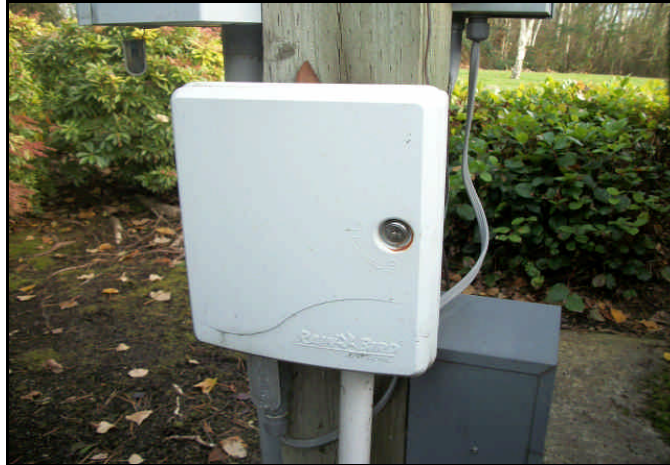
If properly installed and bedded without defect, the lines themselves are expected to be long-lived with no predictable expectation for replacement. Although large system renovations, repairs, zone reconfiguration, etc. may become necessary, difficult to predict timing, scope, cost, therefore no reserve funding recommended here.

As routine maintenance, inspect regularly, test system and repair as needed. Follow proper winterization and spring start up procedures.

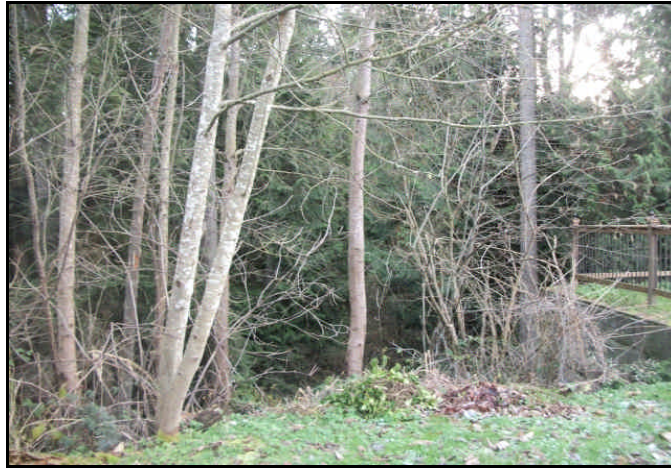
Location: Scattered borders of community

Evaluation: In Section 1.5.5 of the community declarations it states that these NGPA's are considered common area. No problems observed in these areas based on our boundary area inspection. We recommend compliance with any and all governmental regulations regarding these areas. Typically these areas are to remain undisturbed in a substantially natural state; periodic hazard tree removal is typically allowed (see #1890). No basis for large scale reserve funding suggested at this time.

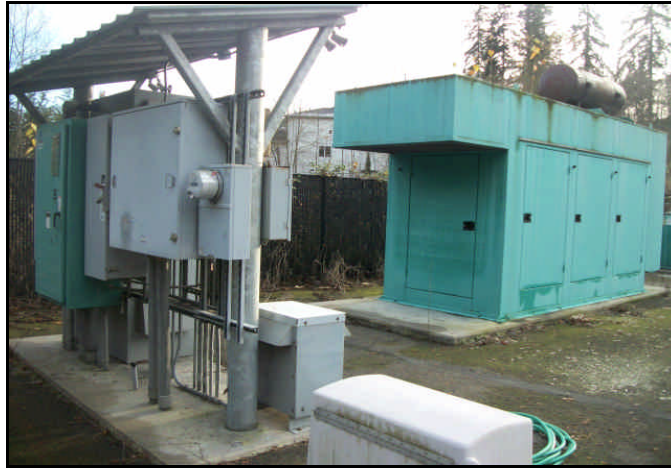
Location: Tract 998 of the community plat map, north end of 51st Ave. SE

Evaluation: In Section 1.5.5 of the community declarations it states that this sewage pump station is considered common area. It has been reported to us, the mechanical elements are the responsibility of the county to maintain. The adjacent signage confirms that it is controlled and maintained by the Silver Lake Water District. We do not suggest any separate funding for these areas, based on the aforementioned information. Any changes in cost or policy can be reflected in future Study updates as needed.

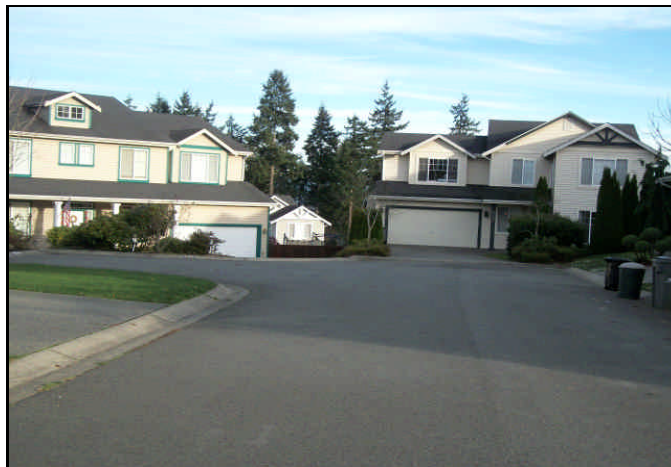
Location: Individual buildings throughout community

Evaluation: The Association is not responsible for any building maintenance and therefore no funding for buildings included within this reserve study.
